SMART EPC: Record of Inspection & Site Notes

Inspection Surveyor:	Rebecca Mcwilliam
E-Mail Address:	rebeccamcdea@gmail.com
Report Reference:	DA1A93D9-354C-4B4B-A299-3A681231D4B5
Created On:	15 October 2025
Date of Inspection:	13 October 2025
Property Address:	18, Oakfield Close, Wrenbury, CW5 8ET
Property Photo

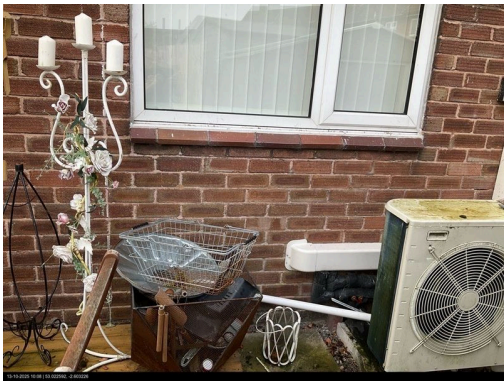
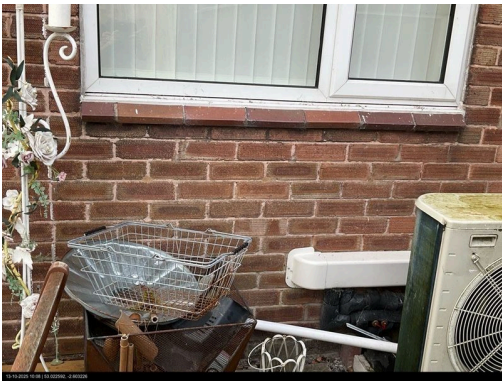
External indicators of Cavity Wall Construction:

stretcher bond, wall thickness over 270 mm

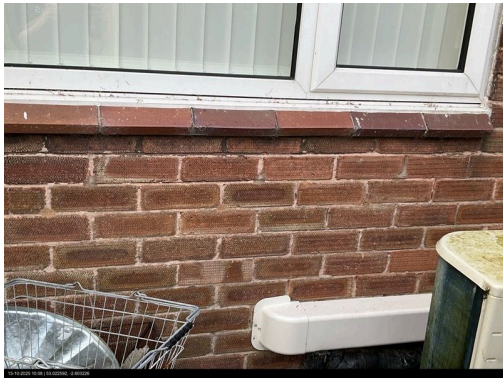
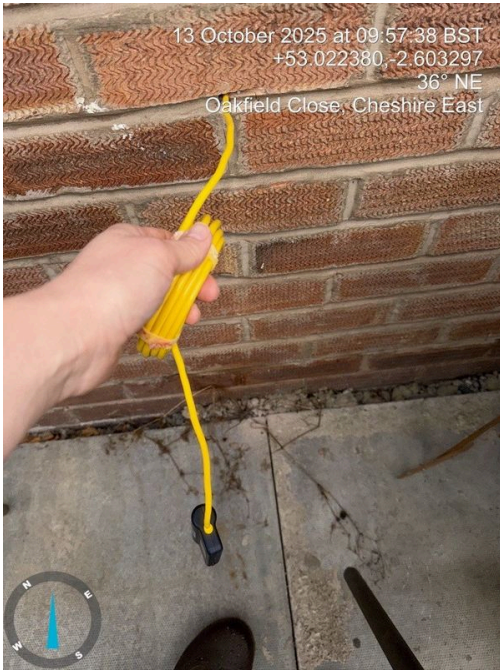
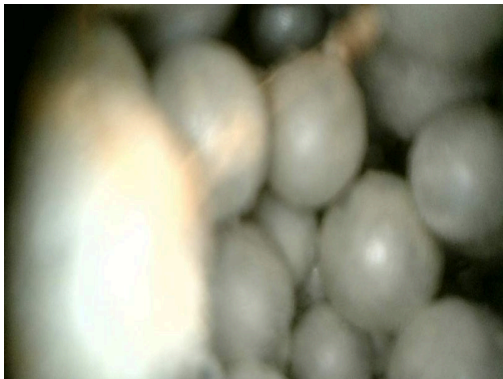
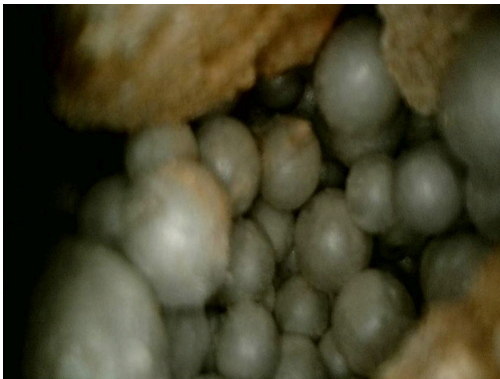
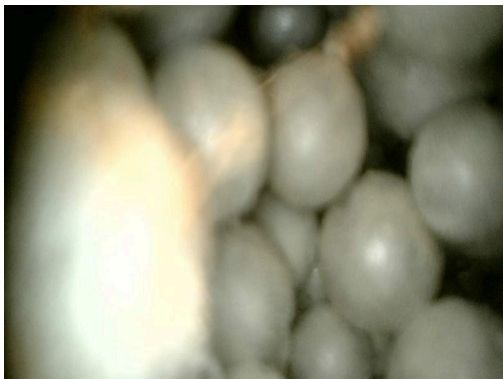
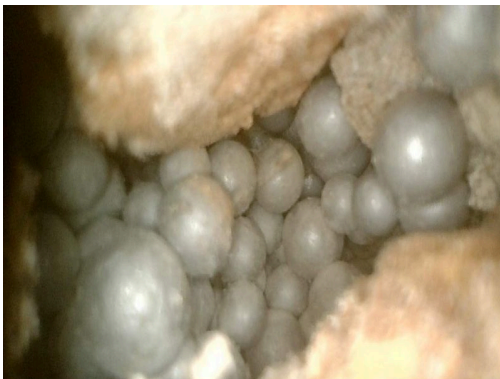
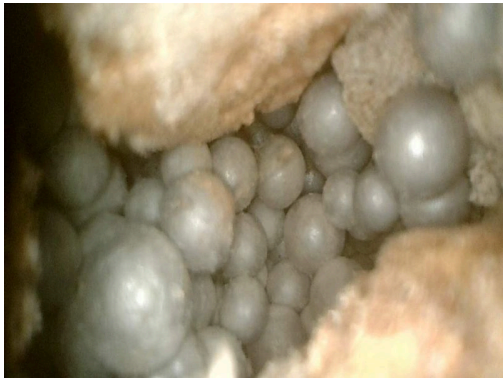
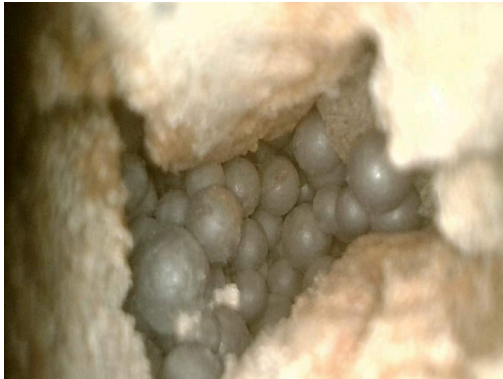
Photo indicators of filled cavity insulation:

evidence of cavity fill drill holes, Boroscope

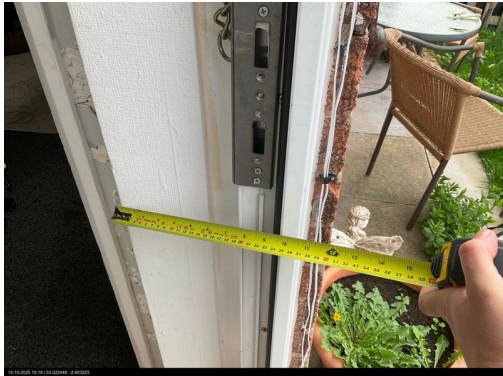
Photo wall thickness:

300 mm

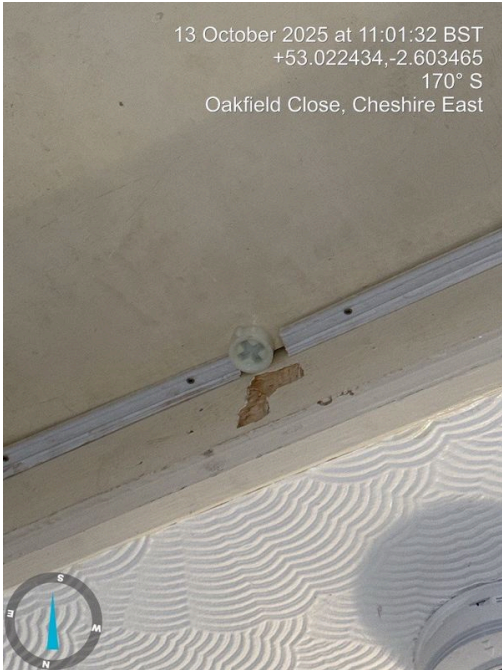
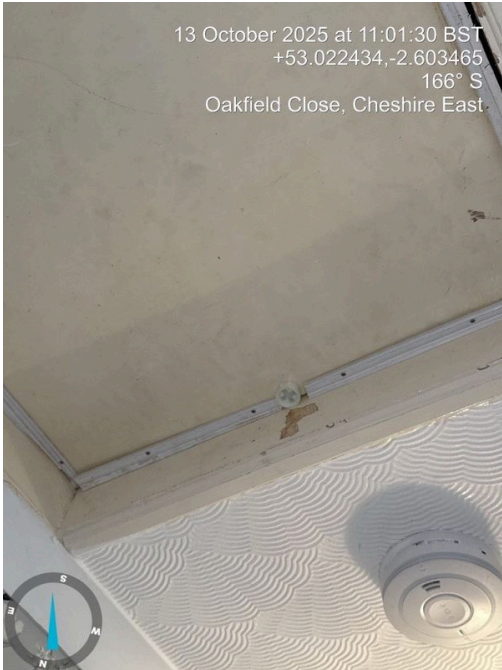
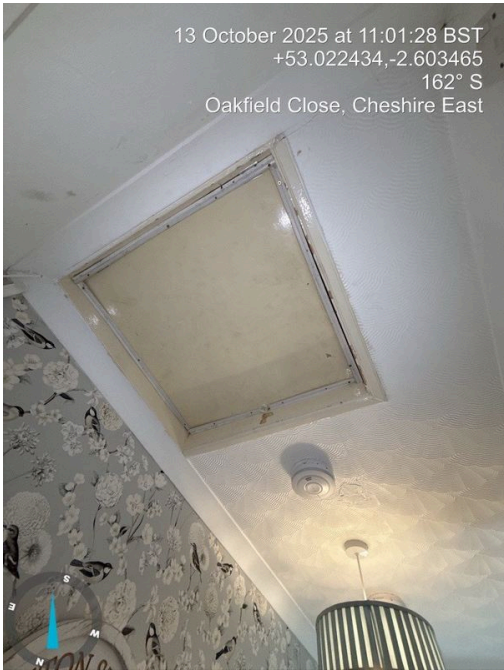
Loft insulation:

Roofs - Construction Type:	Pitched roof (Slates or tiles), No access
Identify the reason for restricted access:	access hatch blocked
Roofs - Insulation At:	Unknown

The loft hatch is a drop-down hatch with a ladder above. The hatch is broken and it could not be opened. She is about to have a new door made so loft will be able to be accessed at some point soon but on the day I could not.
