SMART EPC: Record of Inspection & Site Notes

Inspection Surveyor:	Rebecca Mcwilliam
E-Mail Address:	rebeccamcdea@gmail.com
Report Reference:	Not Applicable
Created On:	14 October 2025
Date of Inspection:	14 October 2025
Property Address:	19, Sandfield , Wrenbury, CW5 8EU
Property Photo

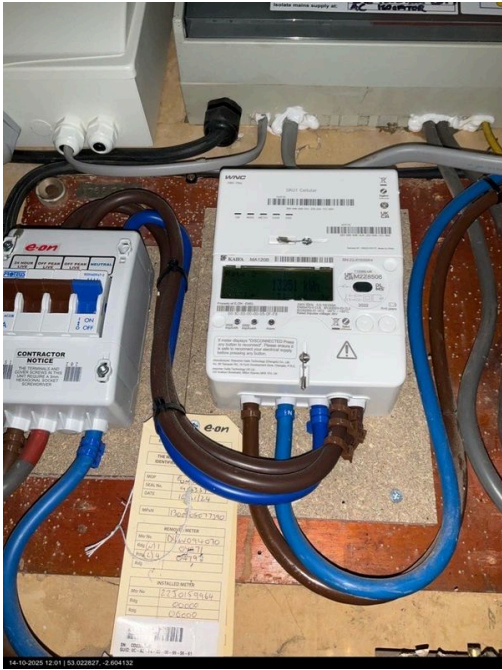
Photo of electricity meter:

Confirm you have checked for the existence of an EPC before carrying out another energy assessment.	Yes
Does an EPC exist at the point of carrying out this energy assessment?	Yes
Please select why another energy assessment needs to be undertaken:	Assessor instructed to produce a new EPC upon request from building owner/tenant/landlord after confirming to the requestor that a valid EPC already exists
Inspection Date:	14/10/2025
Transaction Type:	None of the Above
Tenure:	Rented Social
Type of Property:	House
Detachment Type:	End-terrace
Number of storeys:	2 Storeys
Terrain Type:	Suburban
Number of Extensions:	No Extensions
Is an electricity smart meter present?	Yes
Electric meter type:	Dual

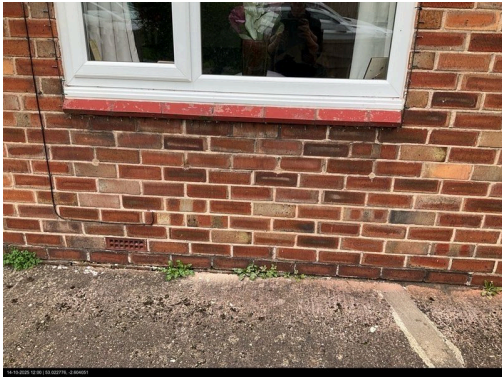
External indicators of Cavity Wall Construction:

Age Range:	1950-1966
Record indicators of property age:	local knowledge, enquiries of owner, period building features
Walls - Construction Type:	Cavity
Record external indicators of Cavity Construction:	stretcher bond

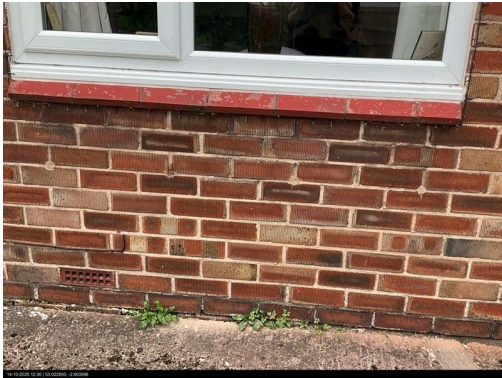
Photo indicators of filled cavity insulation:

Walls - Insulation Type:	Filled Cavity
Record indicators of filled cavity:	evidence of cavity fill drill holes

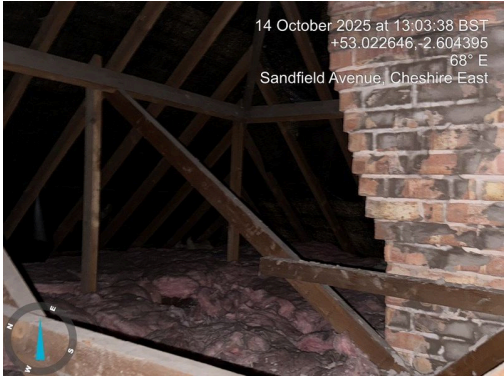
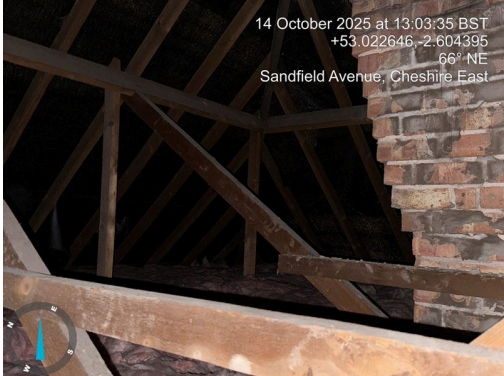
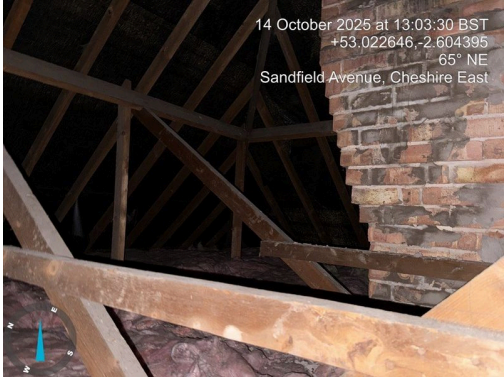
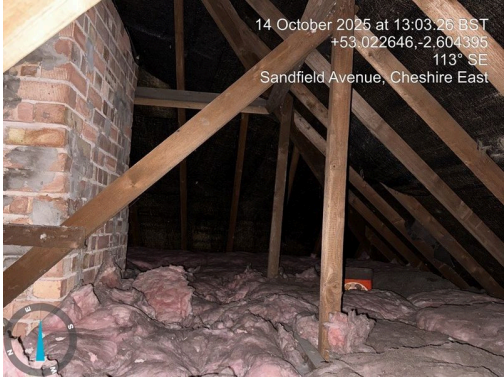
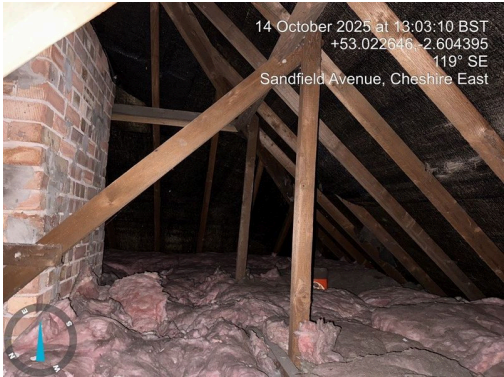
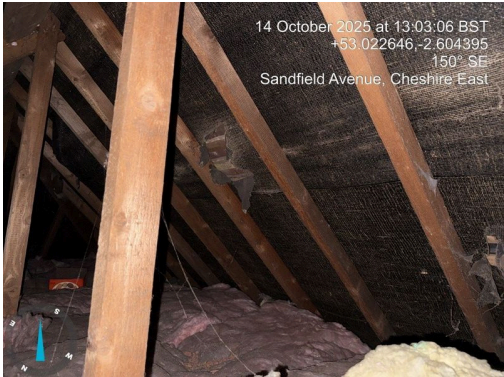
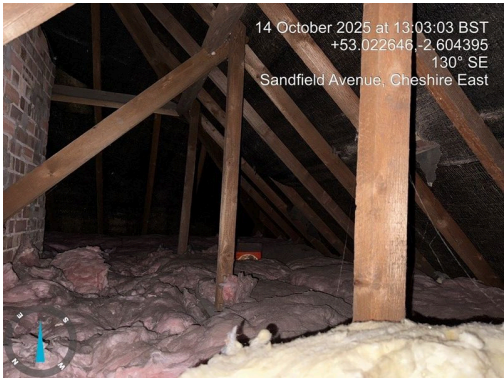
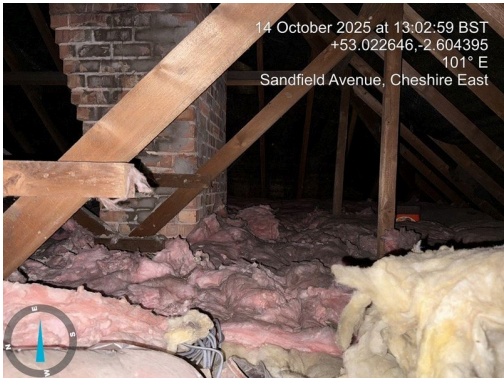
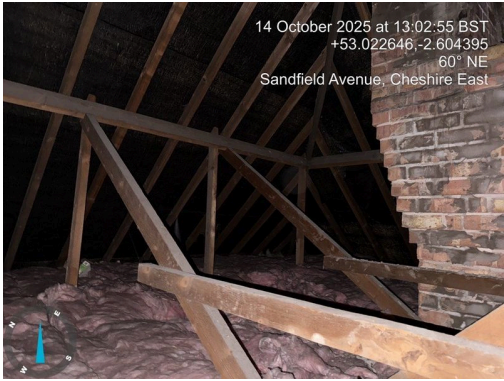
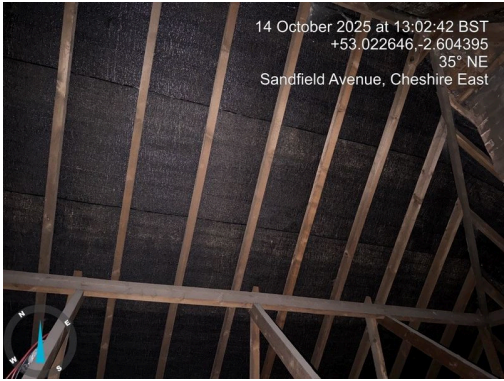
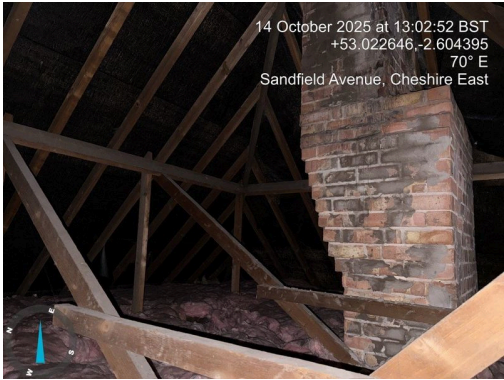
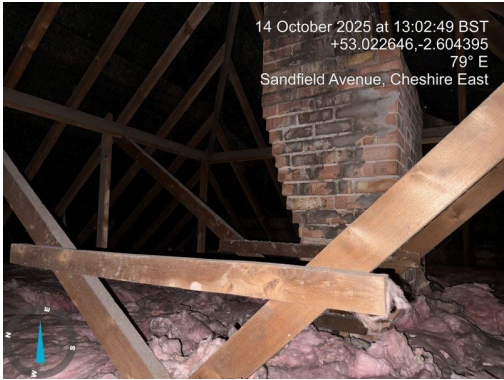
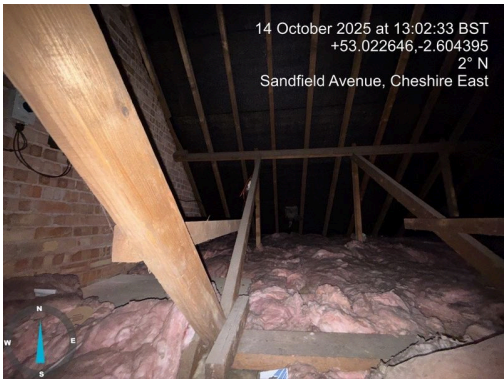
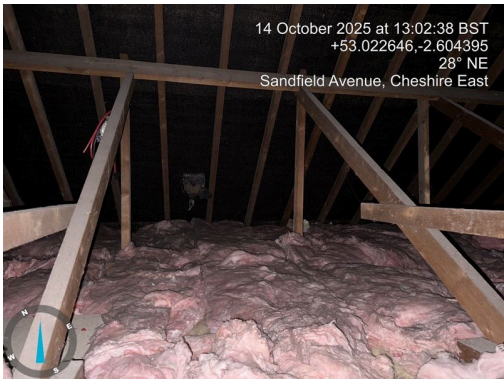
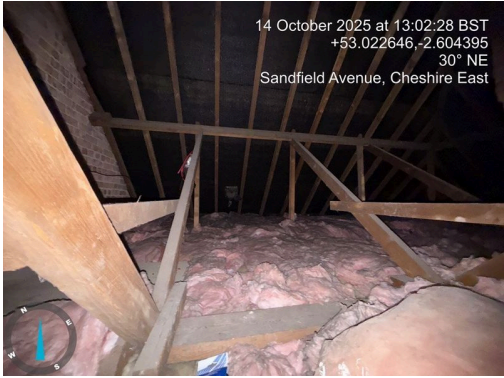
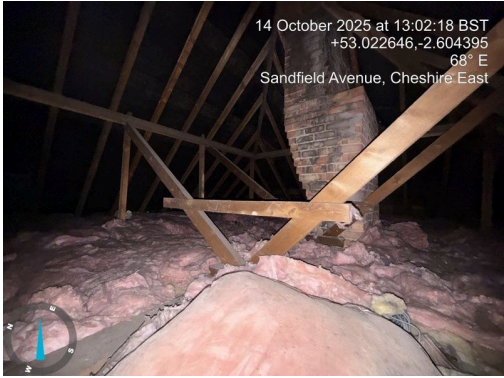
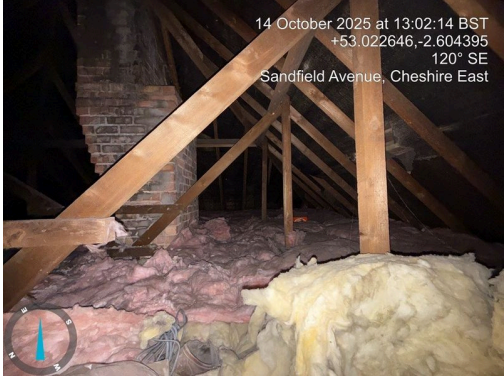
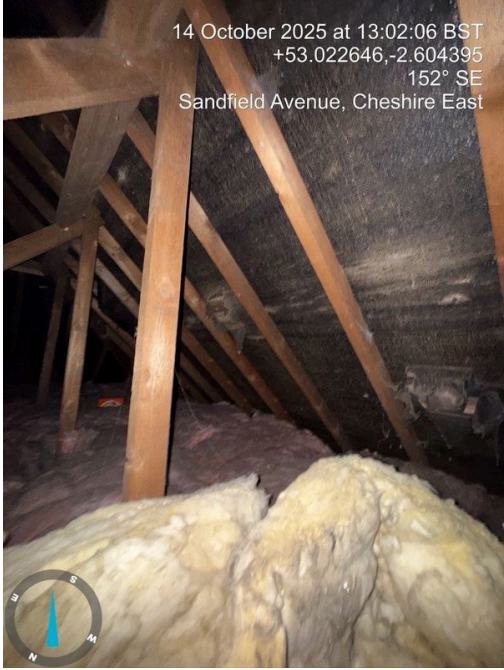
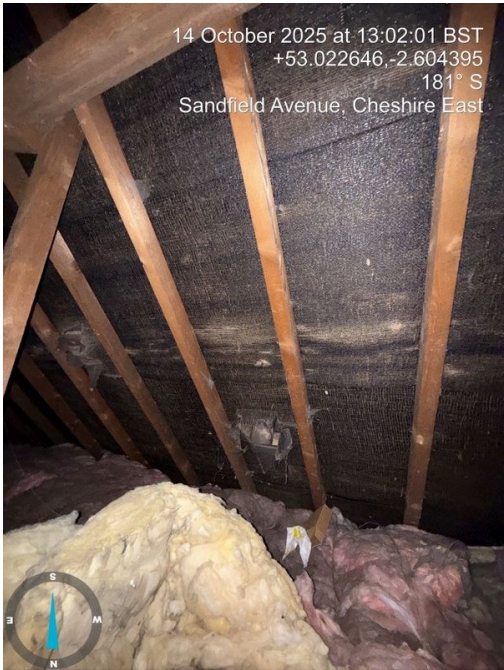
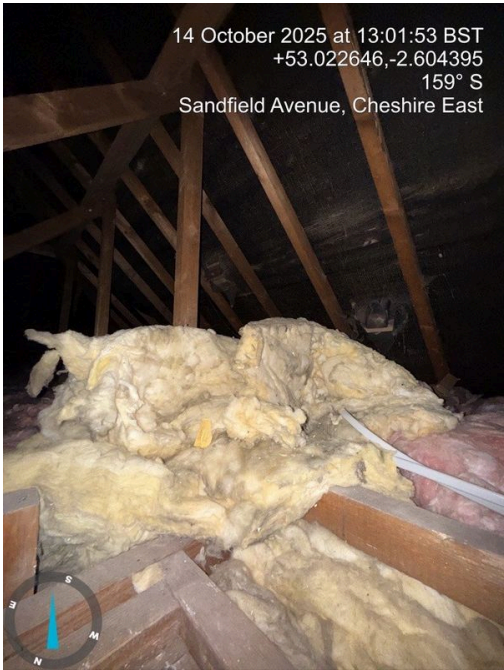
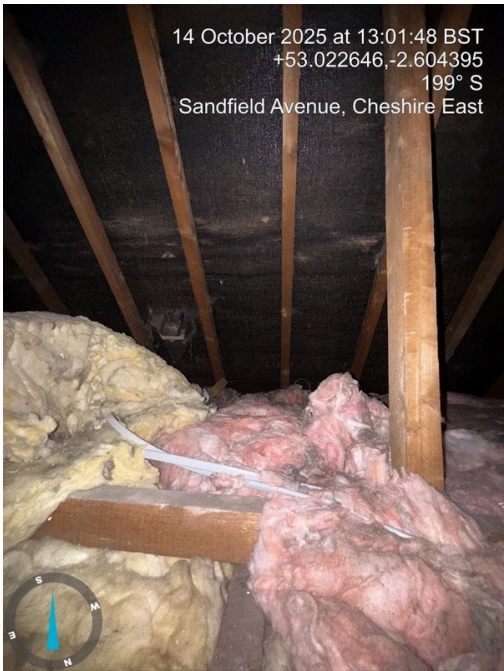
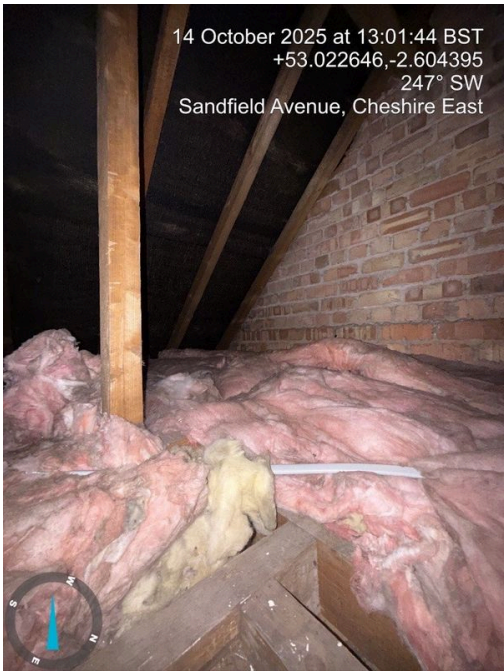
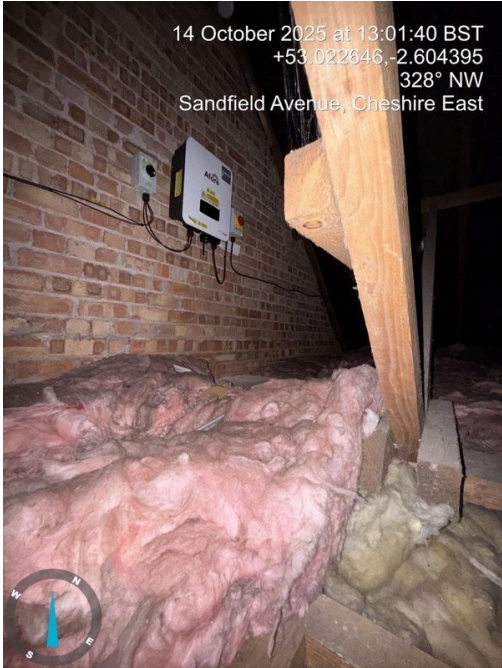
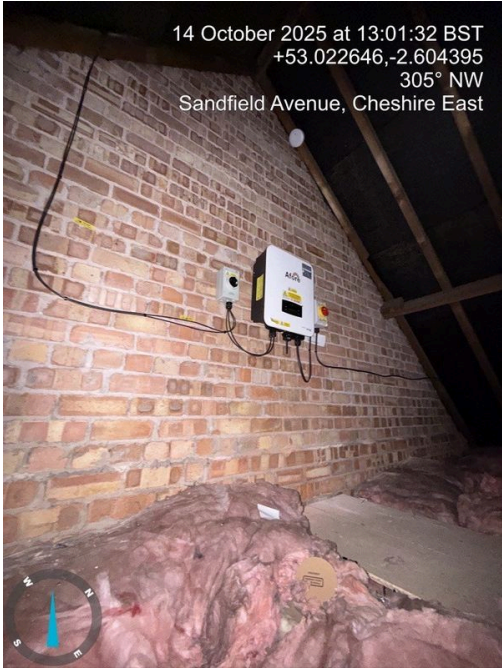
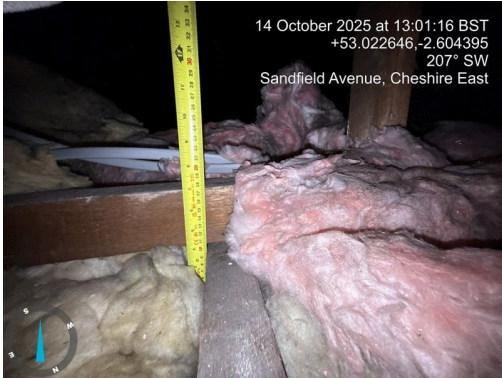
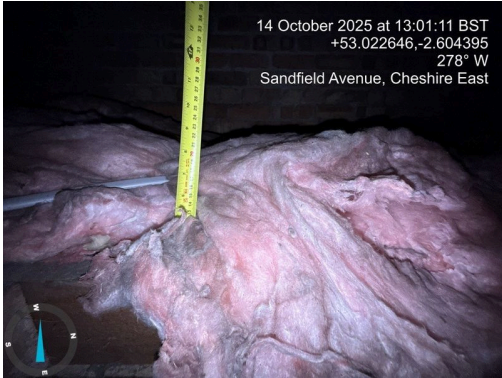
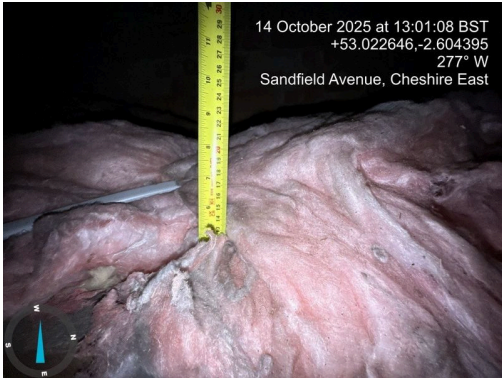
Loft insulation:

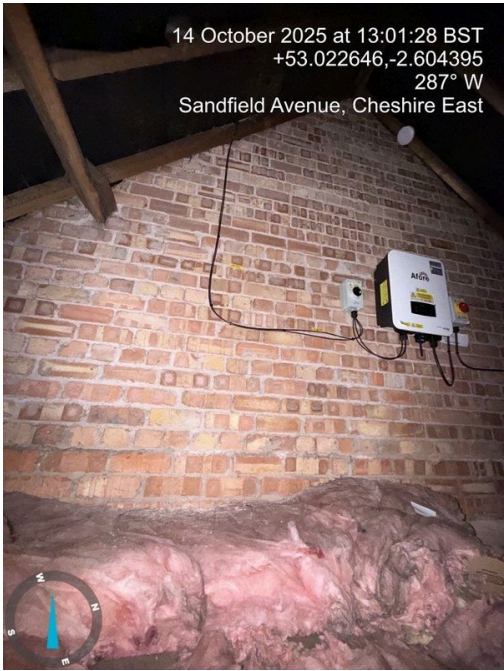
Record indicators of party wall construction in roof space:

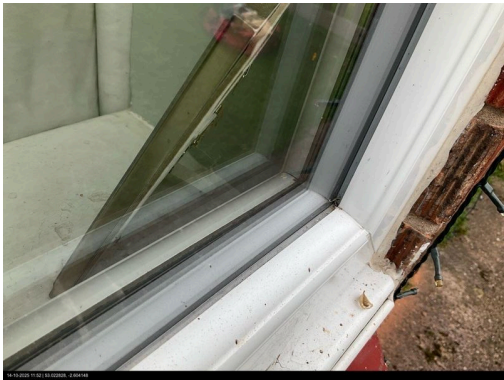
Photo of glazing type:

Window location:	Main Building
Window wall type:	External wall
Glazing Type:	Double glazing installed between 2002 - 2021

Identify basis of window dating:	Thermal spacer bar
Window type:	Window
Window frame type:	Wooden or PVC
Is the window draught proofed?	Yes
Are there permanent shutters present?	No
Window height:	1.26 m
Window width:	1.54 m
Orientation:	North East

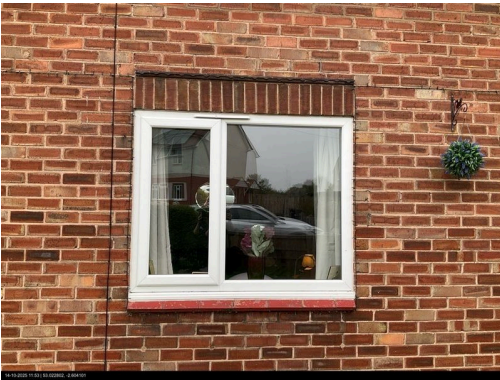
Window 1

Photo of glazing type:

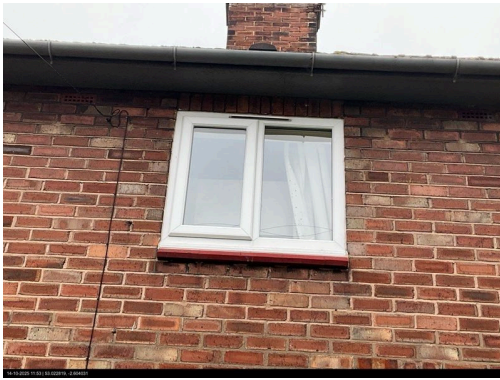
Window 2	
Window location:	Main Building
Window wall type:	External wall
Glazing Type:	Double glazing installed between 2002 - 2021
Identify basis of window dating:	Thermal spacer bar
Window type:	Window
Window frame type:	Wooden or PVC
Is the window draught proofed?	Yes
Are there permanent shutters present?	No
Window height:	0.97 m
Window width:	1.04 m
Orientation:	North East

Photo of glazing type:

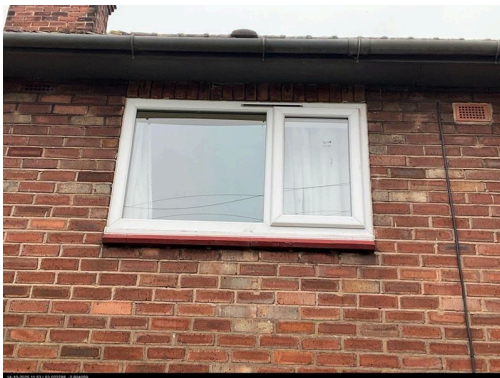
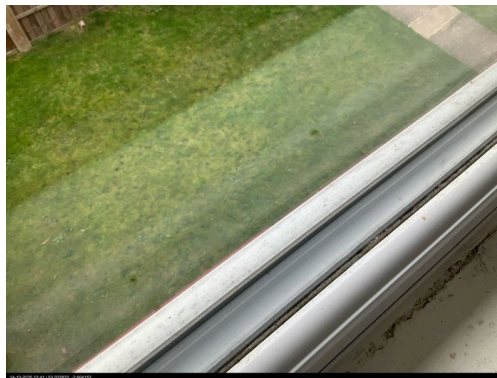
Window 3

Window location:	Main Building
Window wall type:	External wall
Glazing Type:	Double glazing installed between 2002 - 2021
Identify basis of window dating:	Thermal spacer bar
Window type:	Window
Window frame type:	Wooden or PVC
Is the window draught proofed?	Yes
Are there permanent shutters present?	No
Window height:	0.97 m
Window width:	1.53 m
Orientation:	North East

Photo of glazing type:

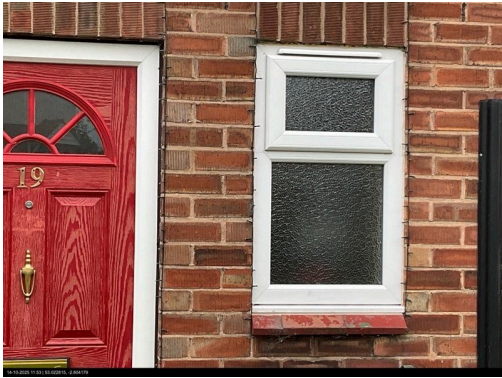
Window 4

Window location:	Main Building
Window wall type:	External wall
Glazing Type:	Double glazing installed between 2002 - 2021
Identify basis of window dating:	Thermal spacer bar
Window type:	Window

Window frame type:	Wooden or PVC
Is the window draught proofed?	Yes
Are there permanent shutters present?	No
Window height:	1.27 m
Window width:	0.58 m
Orientation:	North East

Photo of glazing type:

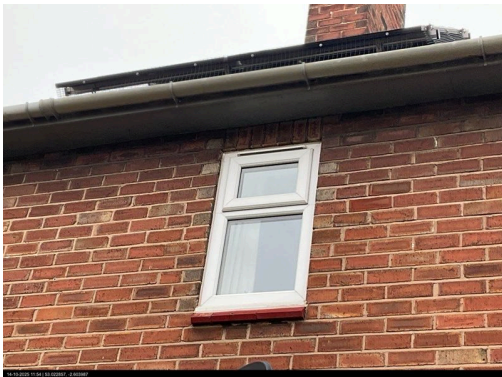
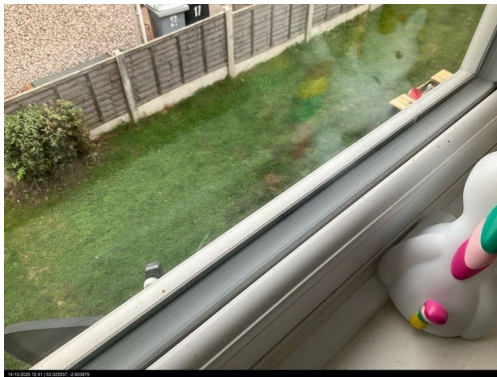
Window 5

Window location:	Main Building
Window wall type:	External wall
Glazing Type:	Double glazing installed between 2002 - 2021
Identify basis of window dating:	Thermal spacer bar
Window type:	Window
Window frame type:	Wooden or PVC
Is the window draught proofed?	Yes
Are there permanent shutters present?	No
Window height:	0.98 m
Window width:	0.54 m
Orientation:	South East

Photo of glazing type:

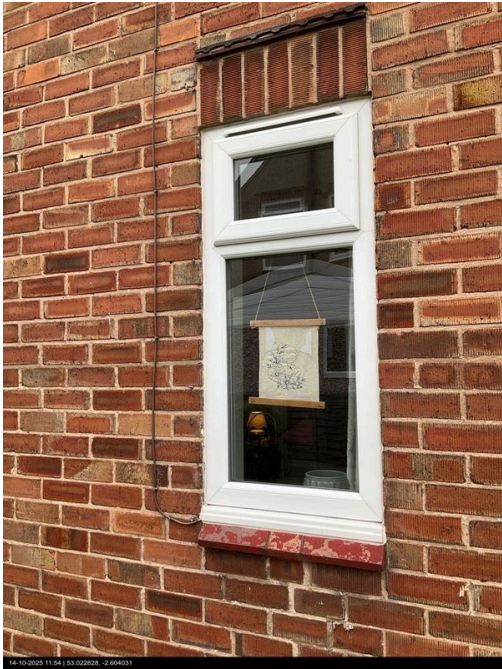
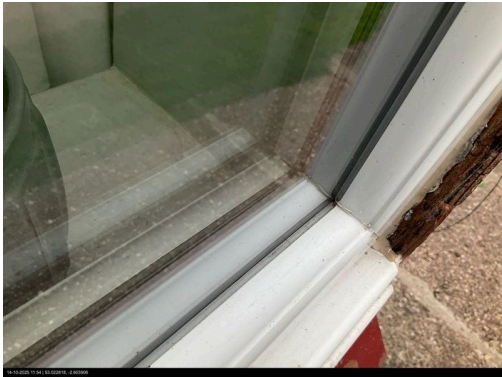
Window 6	
Window location:	Main Building
Window wall type:	External wall
Glazing Type:	Double glazing installed between 2002 - 2021
Identify basis of window dating:	Thermal spacer bar
Window type:	Window
Window frame type:	Wooden or PVC
Is the window draught proofed?	Yes
Are there permanent shutters present?	No
Window height:	1.27 m
Window width:	0.58 m
Orientation:	South East

Photo of glazing type:

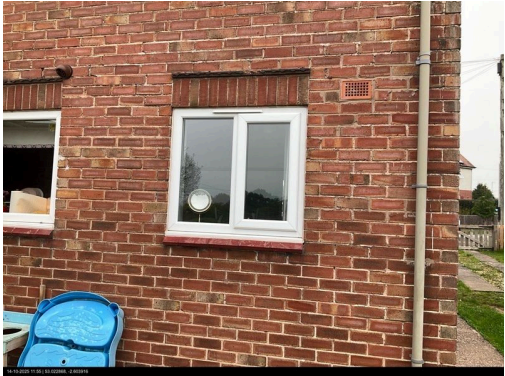
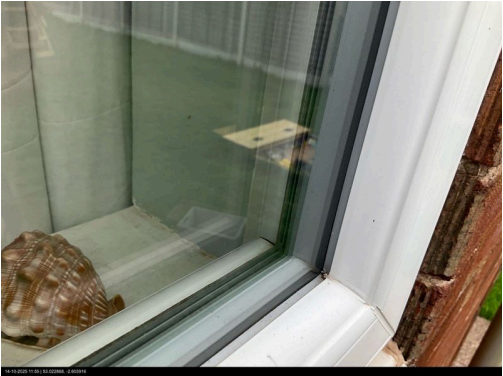
Window 7	
Window location:	Main Building
Window wall type:	External wall
Glazing Type:	Double glazing installed between 2002 - 2021
Identify basis of window dating:	Thermal spacer bar
Window type:	Window
Window frame type:	Wooden or PVC
Is the window draught proofed?	Yes
Are there permanent shutters present?	No
Window height:	0.98 m
Window width:	1.06 m

Photo of glazing type:

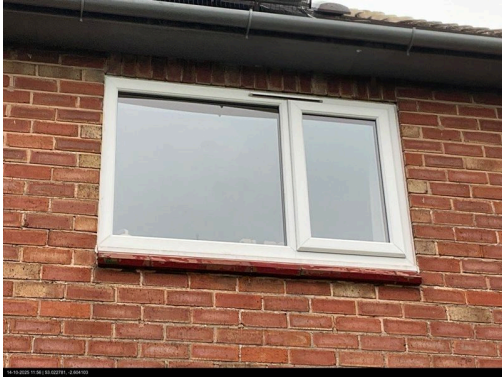
Window 9

Window location:	Main Building
Window wall type:	External wall
Glazing Type:	Double glazing installed between 2002 - 2021
Identify basis of window dating:	Thermal spacer bar

Window type:	Window
Window frame type:	Wooden or PVC
Is the window draught proofed?	Yes
Are there permanent shutters present?	No
Window height:	0.96 m
Window width:	1.53 m
Orientation:	South East

Photo of glazing type:

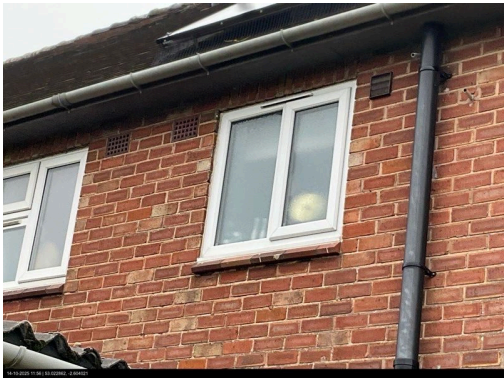
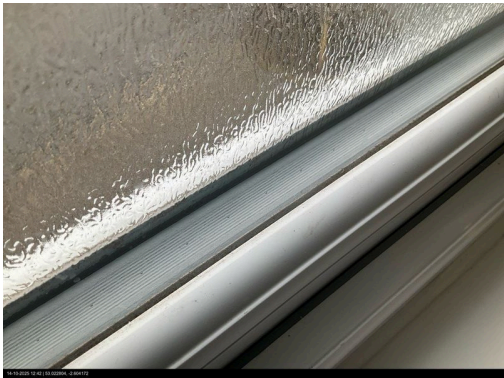
Window 10

Window location:	Main Building
Window wall type:	External wall
Glazing Type:	Double glazing installed between 2002 - 2021
Identify basis of window dating:	Thermal spacer bar
Window type:	Window
Window frame type:	Wooden or PVC
Is the window draught proofed?	Yes
Are there permanent shutters present?	No
Window height:	0.95 m
Window width:	1.04 m
Orientation:	South East

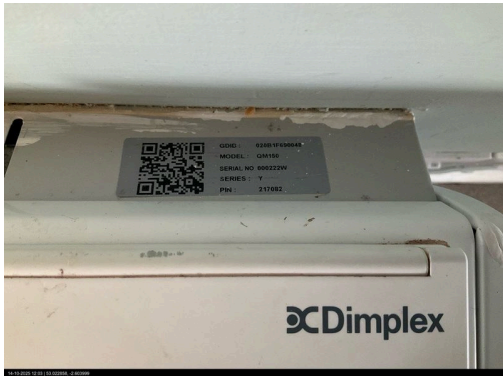
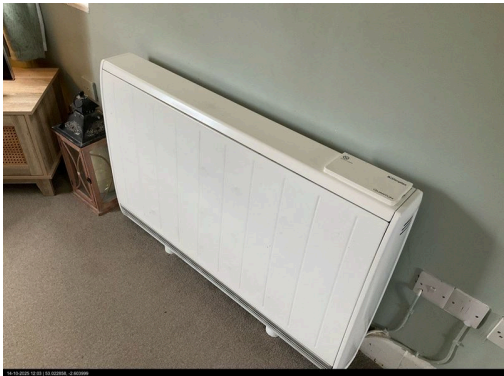
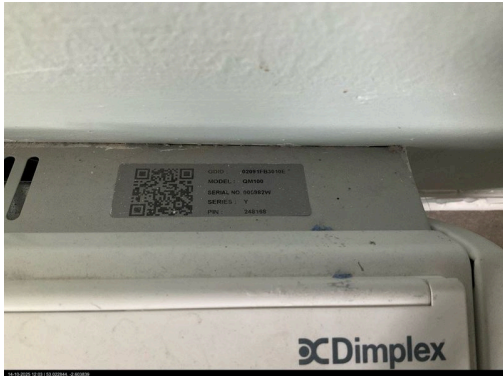
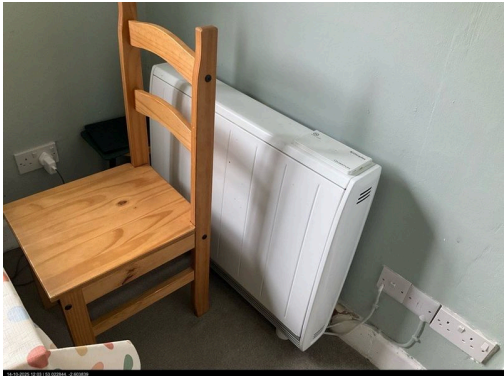
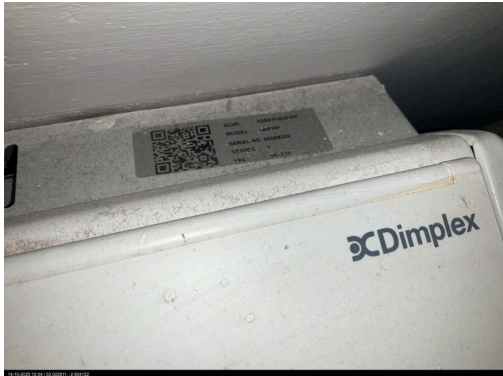
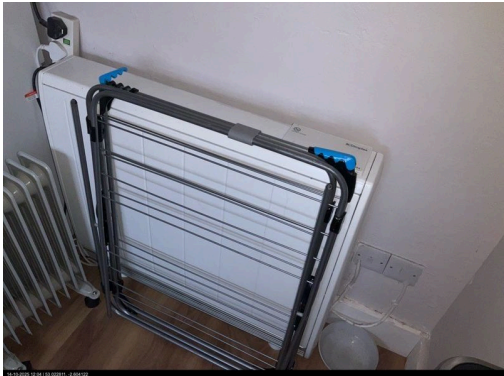
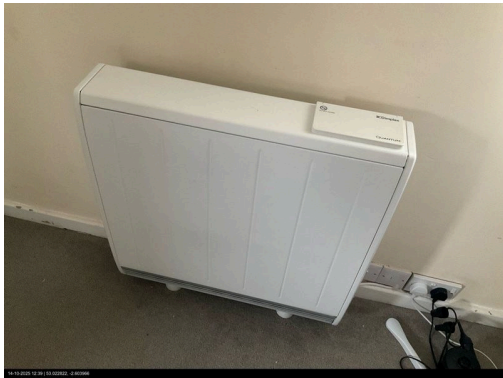
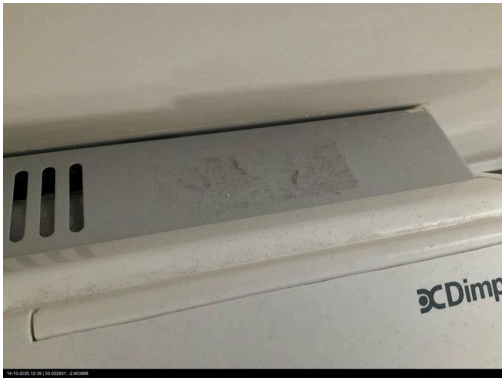
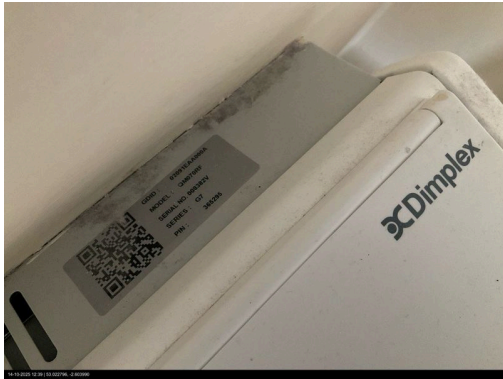
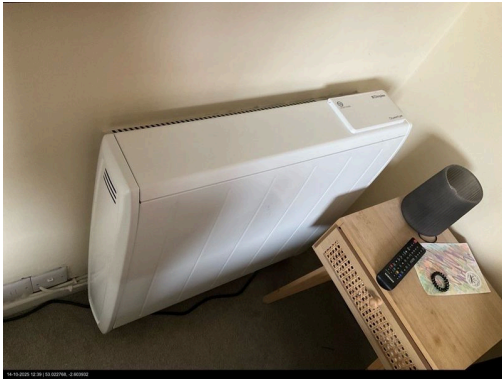
System type:

Electric storage heaters

Controls:

Controls for high heat retention storage heaters

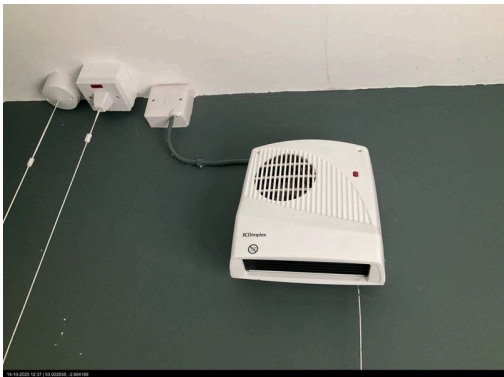
Secondary Fuel	Electricity
Secondary System:	Panel, convector or radiant heaters

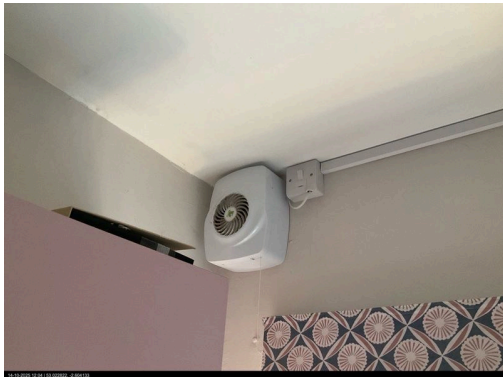
Photo of ventilation type:

Mechanical Extract - Decentralised

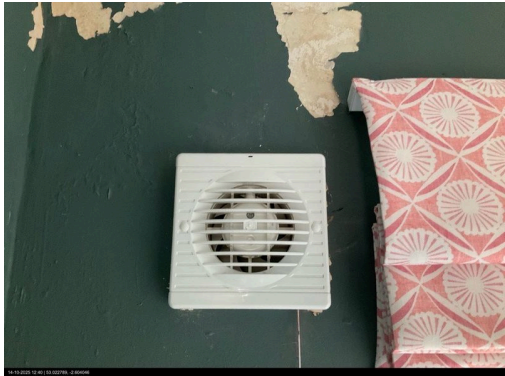
Is the ventilation in the PCDF database?	No
Number of open flues:	0
Number of closed flues:	0
Number of boiler flues:	0
Number of other flues:	0
Number of extract fans:	1

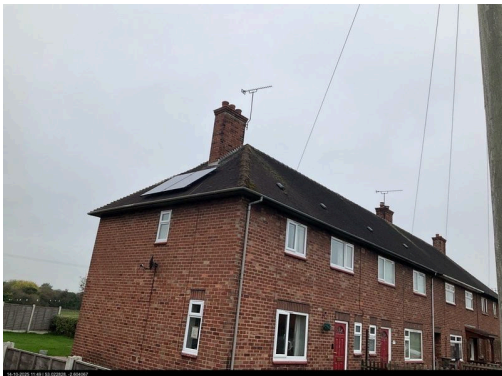
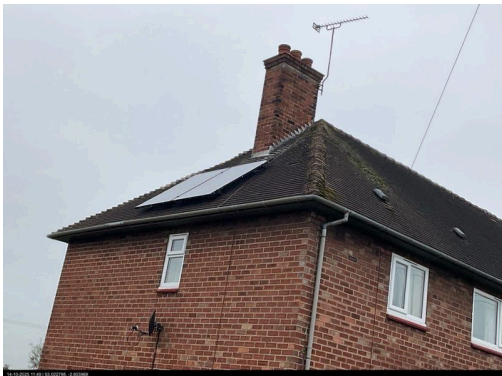
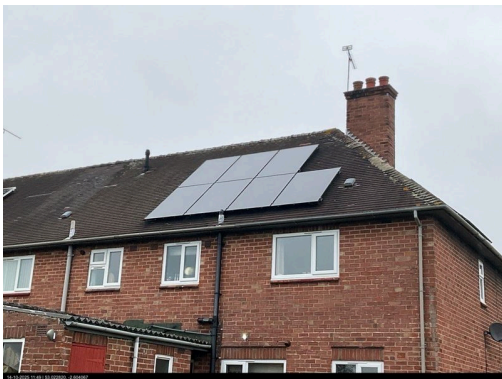
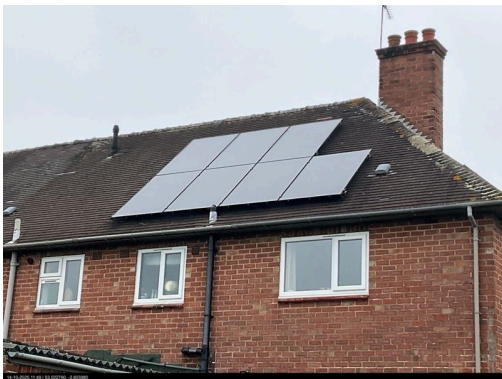
Has photovoltaic array?	Yes
Is there a PV diverter?	No
PV Connection:	Connected to dwellings electricity meter
Photovoltaic array kWp Known?	No
Percentage of roof covered with photovoltaic array?	45 %

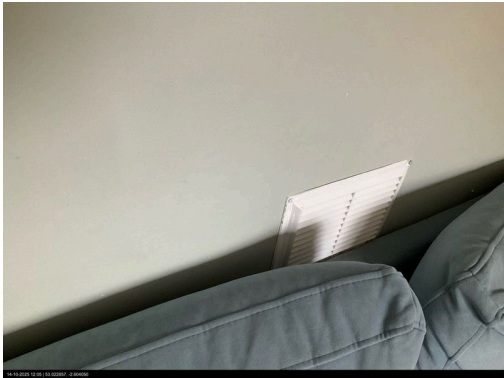
Photo of open chimneys:

Number of external doors?	2
Number of insulated external doors?	0
Number of draughtproofed external doors?	2
Number of open chimneys?	1

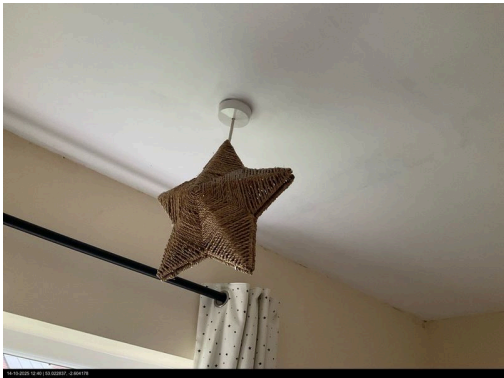
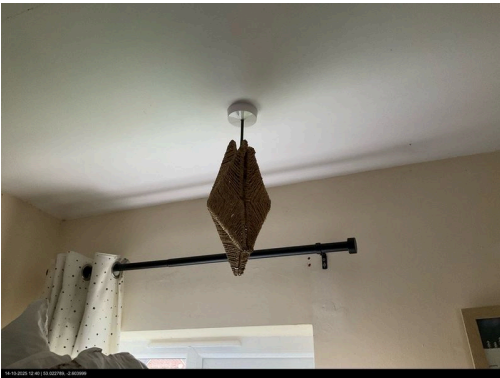
Number of blocked chimneys?	0
Number of fixed incandescent bulbs:	2

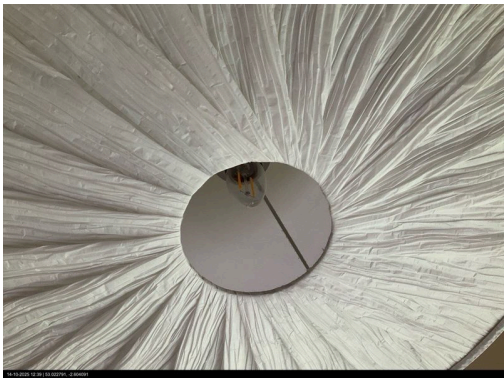
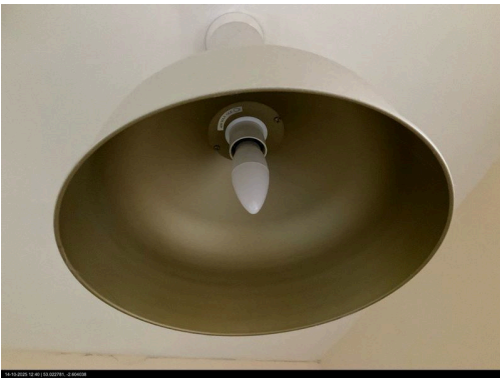
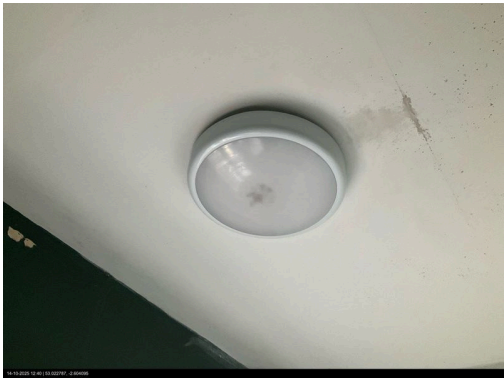
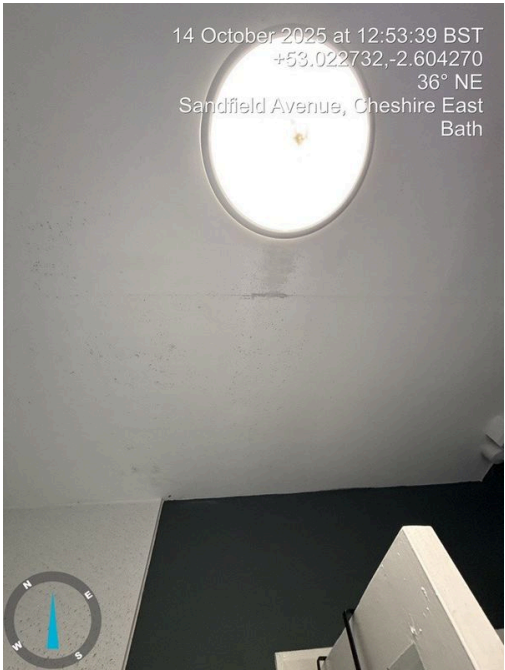
Is the exact number of LED and CFL bulbs known?	Yes
Number of fixed LED bulbs:	9

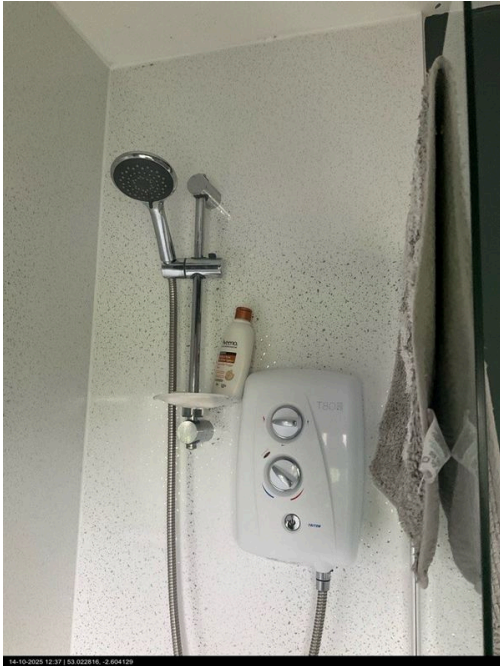
Photo of shower:

Electric Shower
