# SMART EPC: Record of Inspection & Site Notes

Inspection Surveyor:	Robert Rhodes
E-Mail Address:	rods30@live.co.uk
Report Reference:	2B688EF1-FE12-4F7E-860A-E63ABA4FEA47
Created On:	8 November 2025
Date of Inspection:	01 October 2025
Property Address:	34, Acton Road, Crewe, Cheshire, CW2 8TN
Property Photo	<div><div><div>N0306090120S</div><div>63°NE (M) 53°6'2"N, 2°28'53"W ±45ft ▲ 184ft</div>

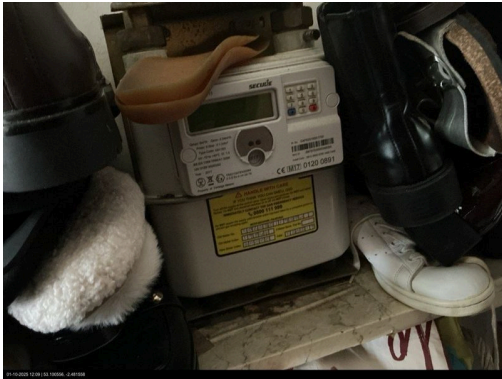
Photo of Gas Meter:

Is the dwelling export-capable?	Yes
Is mains gas available?	Yes
Is there a gas smart meter?	Yes
Is the gas meter accessible?	Yes

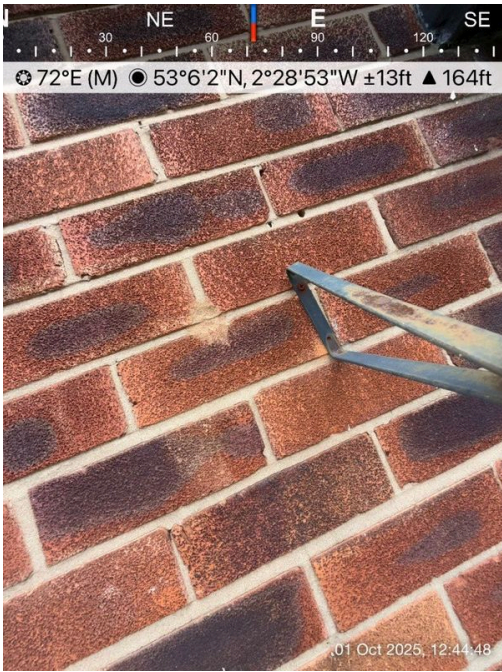
External indicators of Cavity Wall Construction:

Age Range:	1950-1966
Record indicators of property age:	local knowledge, enquiries of owner
Walls - Construction Type:	Cavity
Record external indicators of Cavity Construction:	stretcher bond, wall thickness over 270 mm, evidence of cavity fill drill holes, Drilled and boroscoped

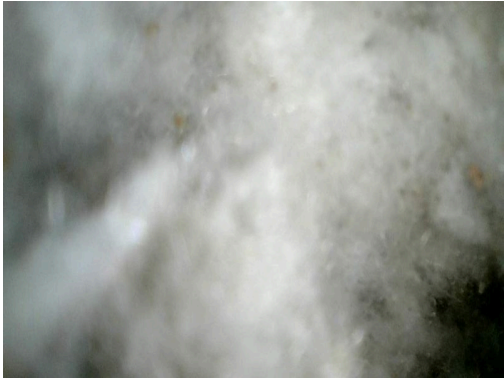
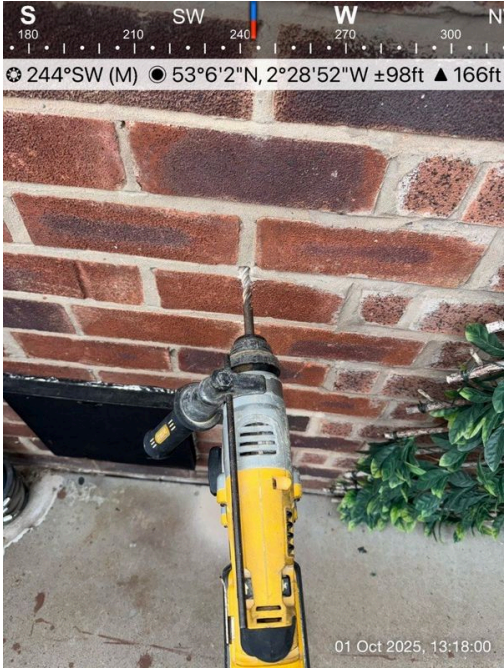
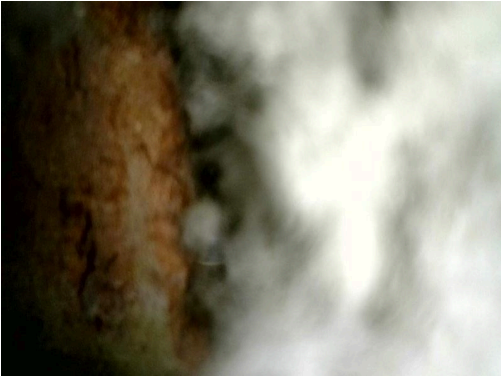
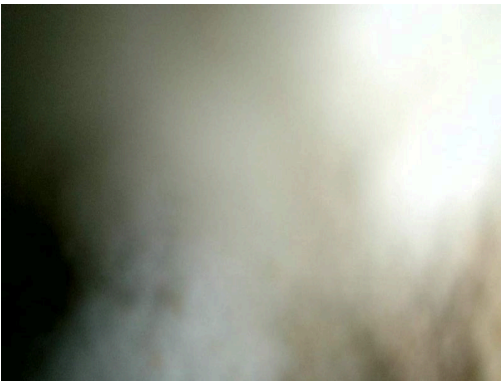
Photo indicators of filled cavity insulation:

Filled Cavity

evidence of cavity fill drill holes, Drilled and boroscoped wall

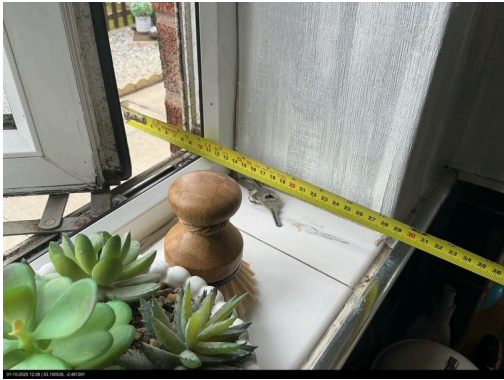
Photo wall thickness:

Thermal conductivity of wall insulation:	Unknown
Wall U-Value known?	Not Known
Wall thickness:	280 mm

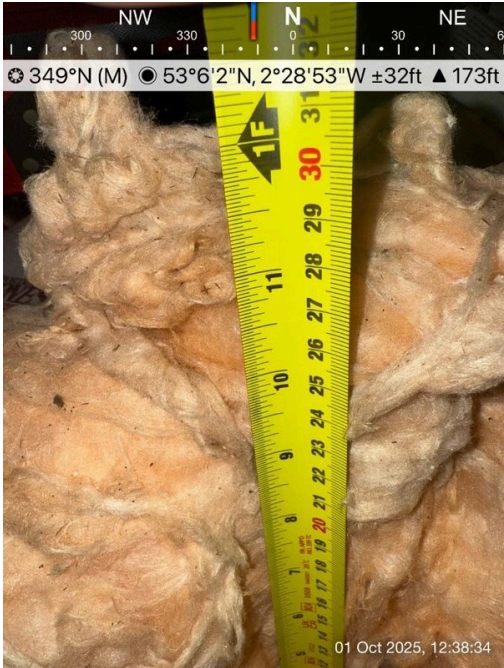
Loft insulation:

Roofs - Construction Type:	Pitched roof (Slates or tiles), Access to loft
Roofs - Insulation At:	Joists
Roof U-Value:	Not Known
Roofs - Insulation Thickness:	300 mm

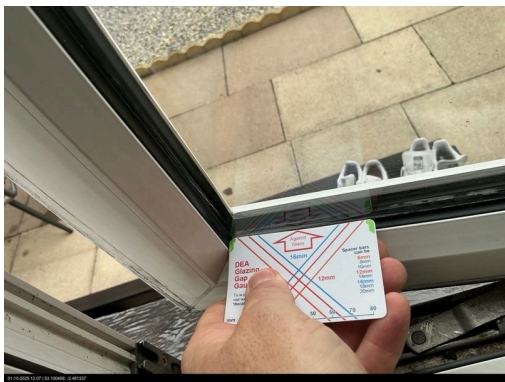
**Photo of glazing type:**

Window location:	Main Building
Window wall type:	External wall
Glazing Type:	Double glazing, Unknown install date
Window type:	Window
Window frame type:	Wooden or PVC
What size is the glazing gap?	12 mm
Is the window draught proofed?	Yes
Are there permanent shutters present?	No
Window height:	0.88 m
Window width:	0.95 m
Orientation:	East

## All Windows the same

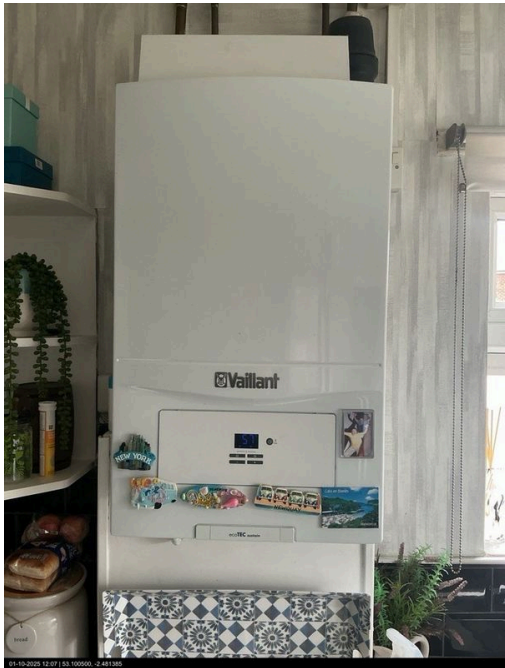
Photo of heating system:

How would you like to select the Heating System?	PCDF Search
System type:	Boiler with radiators or underfloor heating
Product Id	18119
Manufacturer	Vaillant
Model	ecoTEC sustain 28
Orig Manuf	Vaillant
Fuel	Mains gas
S. Efficiency	0
Type	Combi
Condensing	Yes
Year	2017 - current
Mount	Wall
Open Flue	Room-sealed
Fan Assist	Yes
Status	Normal status for an actual product
Central heating pump age:	Unknown
Controls:	Programmer, room thermostat and TRVs
Does the boiler have a Flue Gas Heat Recover System (FGHRS)?	No
Is there a weather compensator?	No
Emitter:	Radiators
Emitter Temperature:	Unknown

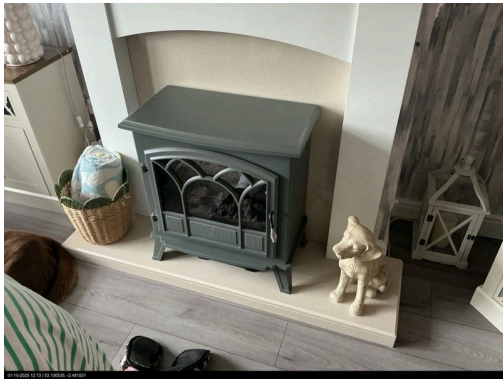
Photo of secondary heating system

Secondary Fuel	Electricity
Secondary System:	Panel, convector or radiant heaters

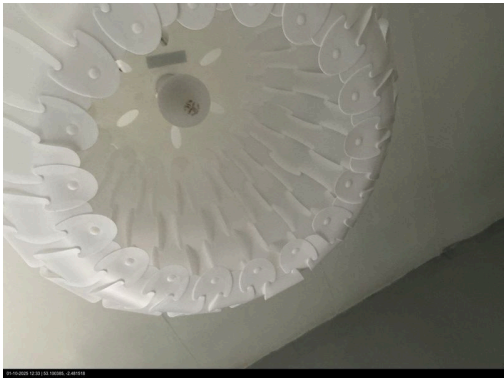
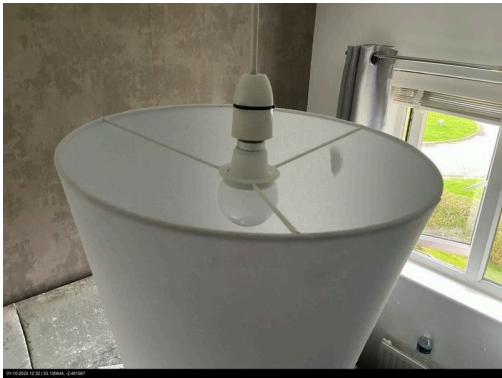
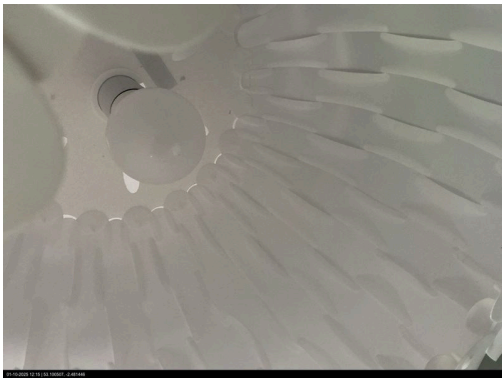
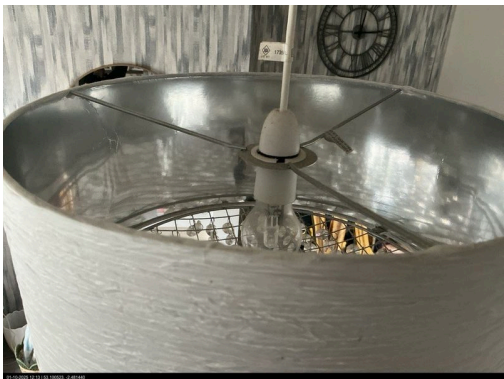
Photo of LED bulbs:

Room Count Elements	
Number of habitable rooms?	4
Are any of these rooms unheated?	No
Number of external doors?	2
Number of insulated external doors?	0
Number of draughtproofed external doors?	2
Number of open chimneys?	0
Number of blocked chimneys?	0
Number of fixed incandescent bulbs:	0
Is the exact number of LED and CFL bulbs known?	Yes
