SMART EPC: Record of Inspection & Site Notes

Inspection Surveyor:	Rebecca Mcwilliam
E-Mail Address:	rebeccamcdea@gmail.com
Report Reference:	DA1A93D9-354C-4B4B-A299-3A681231D4B5
Created On:	15 October 2025
Date of Inspection:	13 October 2025
Property Address:	18, Oakfield Close, Wrenbury, CW5 8ET
Property Photo

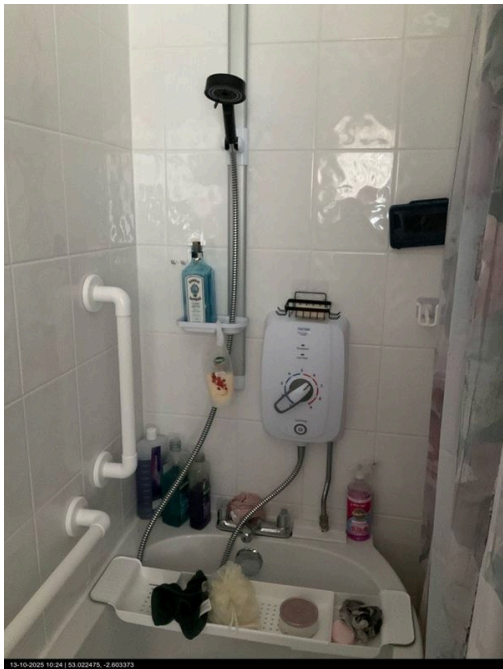
Photo of shower:

Electric Shower
